DOT/FAA/CT-94/56

# Characterization of Corrosion and Development of a Breadboard Model of a D Sight Aircraft Inspection System: Phase I

August 1994

Final Report

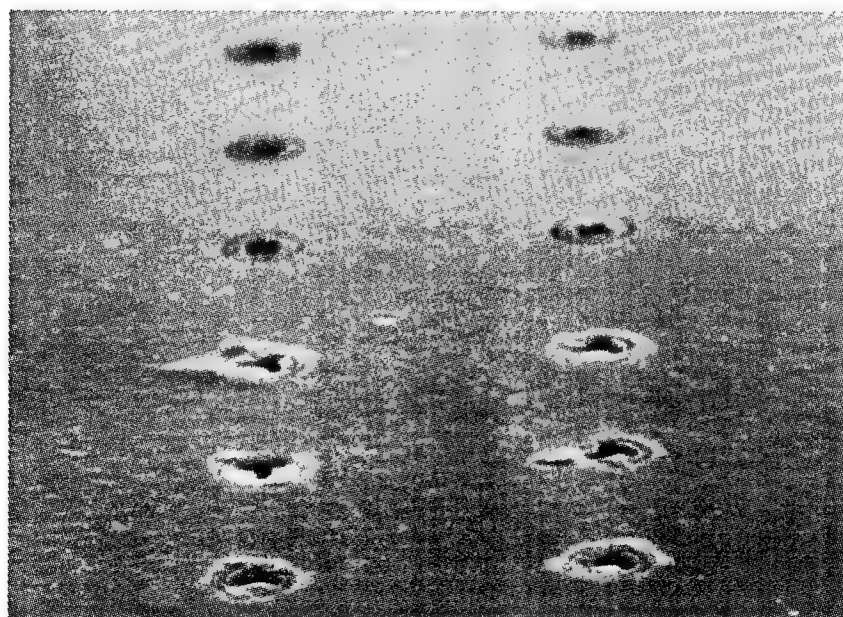
Figure 19 is a good illustration of galvanic corrosion around steel fastener in aluminium alloy. D Sight isolated corroded areas and the findings were later confirmed by ultrasonic inspection.

Figure 19. D Sight image of an aluminium alloy skin with two sets of fasteners. The six lower fasteners precipitated galvanic corrosion which is quite visible under D Sight.

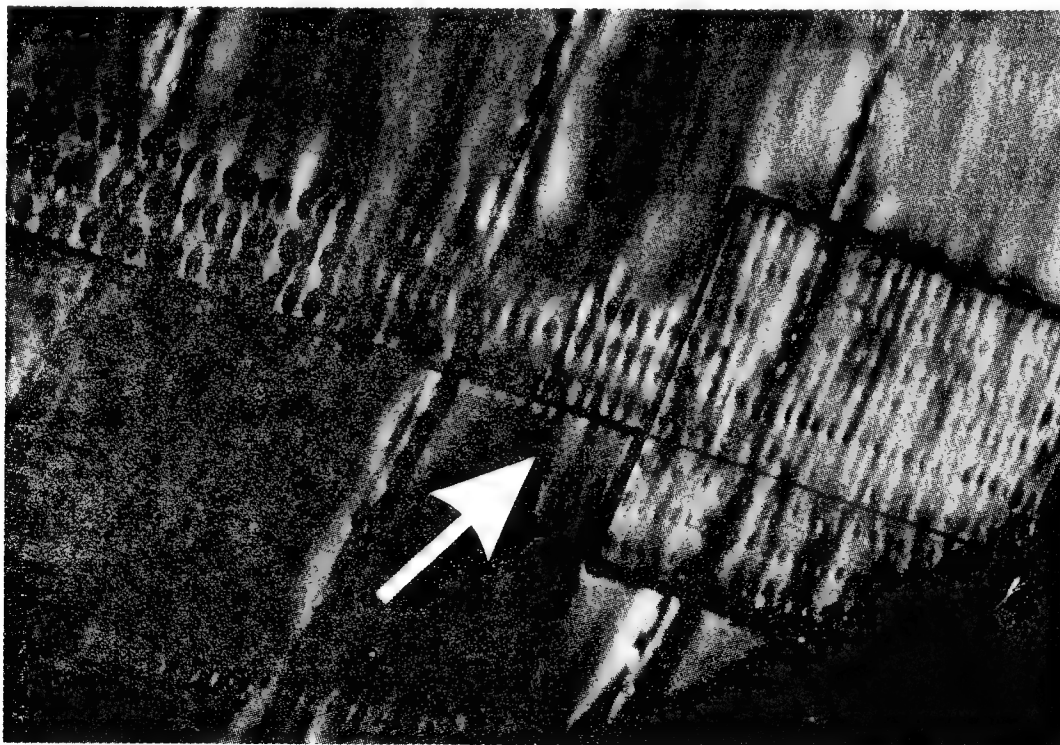
Corrosion in lap joints leads to pillowing (bulging) of skins held together by fasteners or spot welds. This is a very good application of D Sight which has been demonstrated on actual aircraft (B727) as shown in Figure 20.

Figure 20. D Sight image of B727 lap splice showing pillowing in 8 rivet rows outside the patch. Subsequent teardown revealed extensive corrosion.

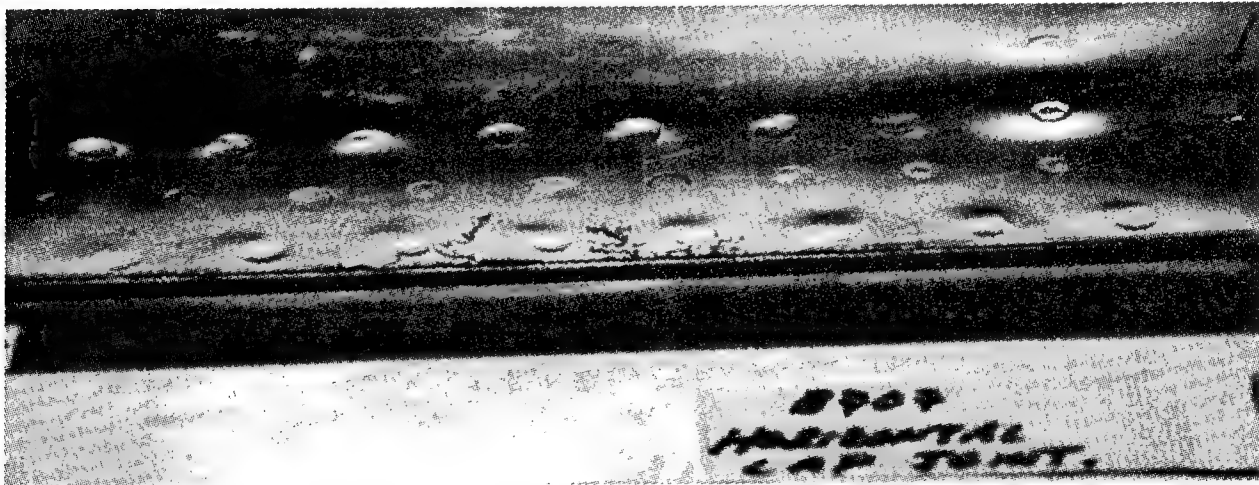
This is a good candidate form of corrosion for D Sight inspection as can be seen in Figure 21.

Figure 21. D Sight image. Filiform corrosion in a lap splice area.

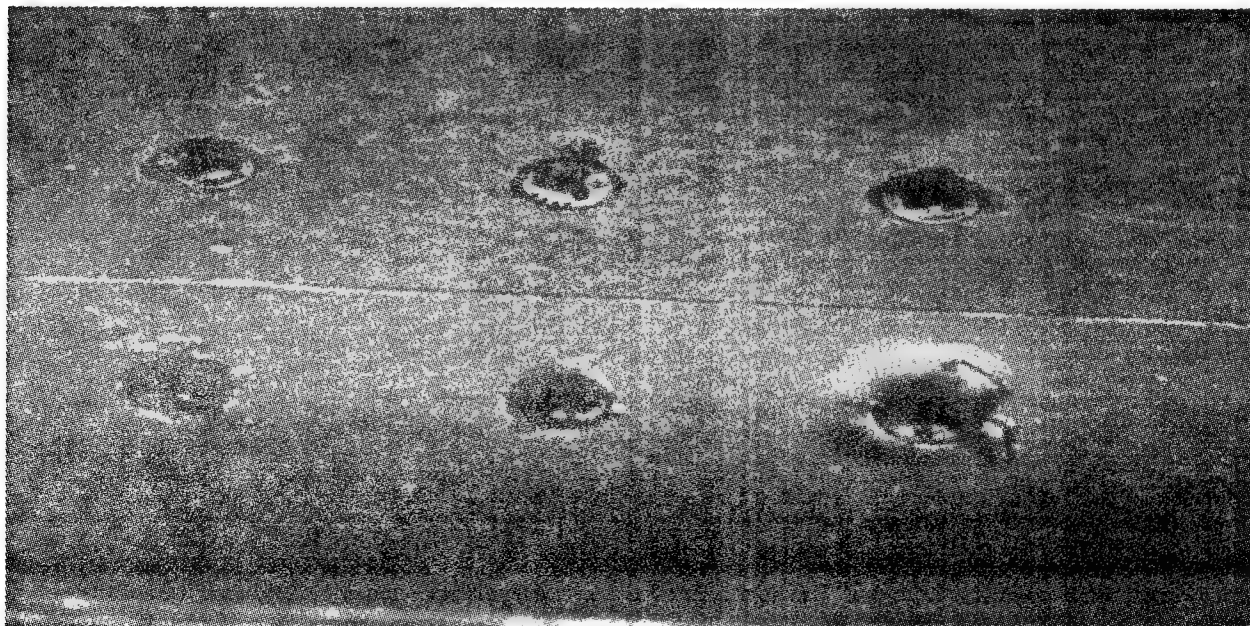
Figure 22 shows D Sight image of heavy exfoliation around fastener caused by galvanic corrosion. Exfoliation by definition will result in surface perturbation and is therefore well suited for D Sight inspection.

Figure 22. D Sight image showing exfoliation around a rivet head.

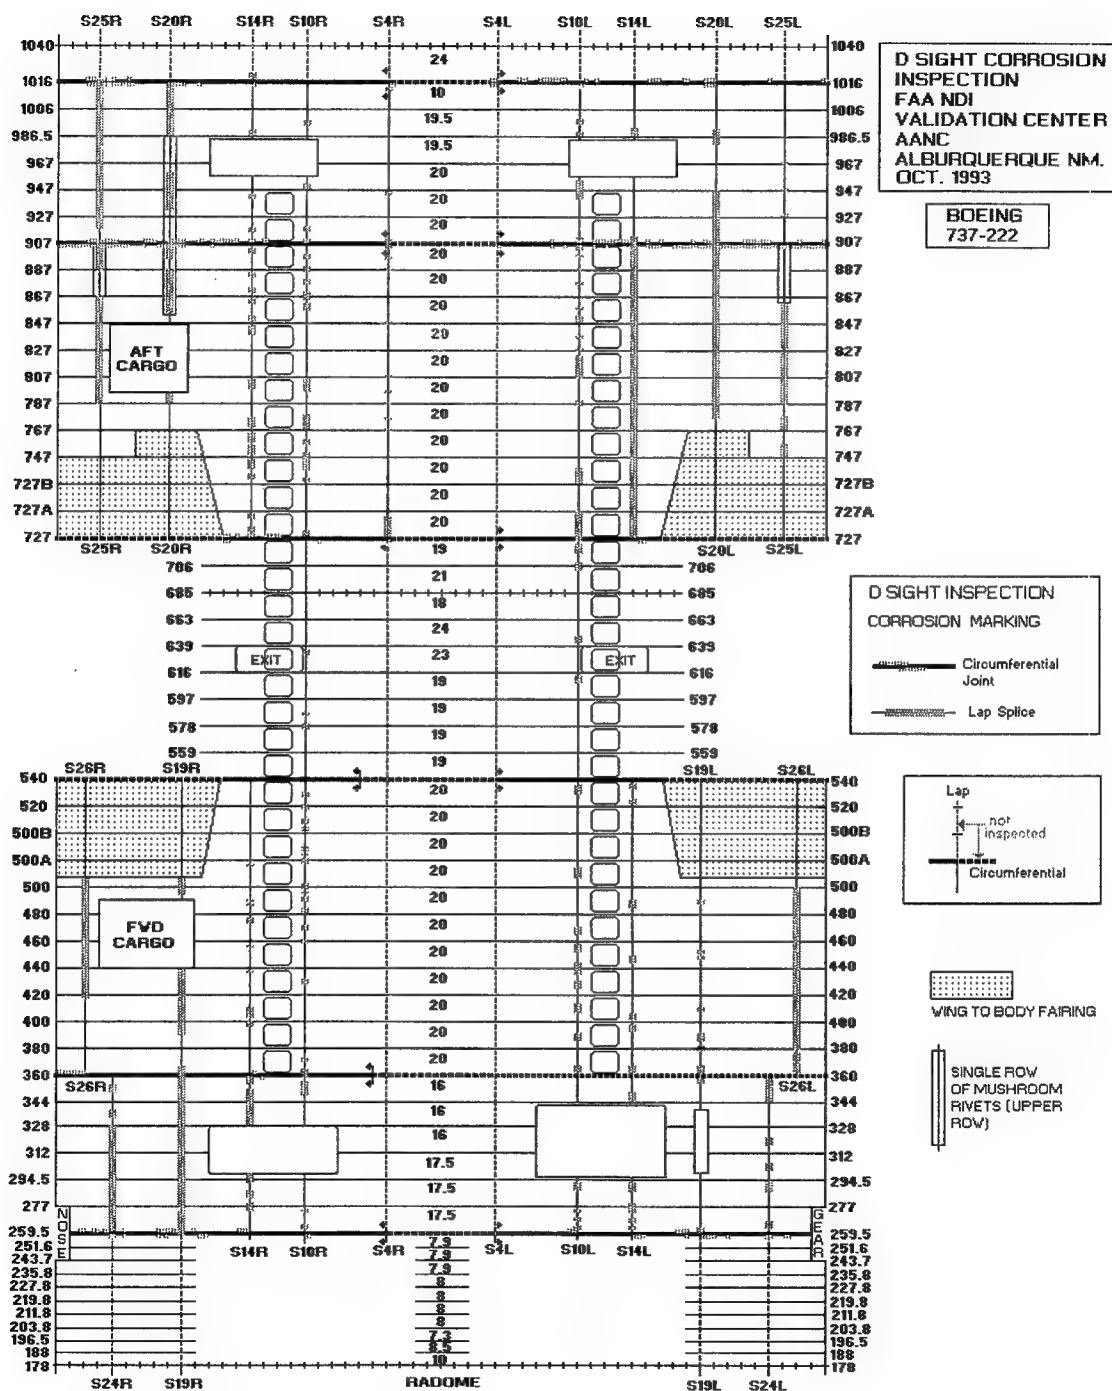
The resulting corrosion map for this aircraft, as determined by *D SIGHT*, is presented in the in the following turtle diagram for horizontal and circumferential lap splices.

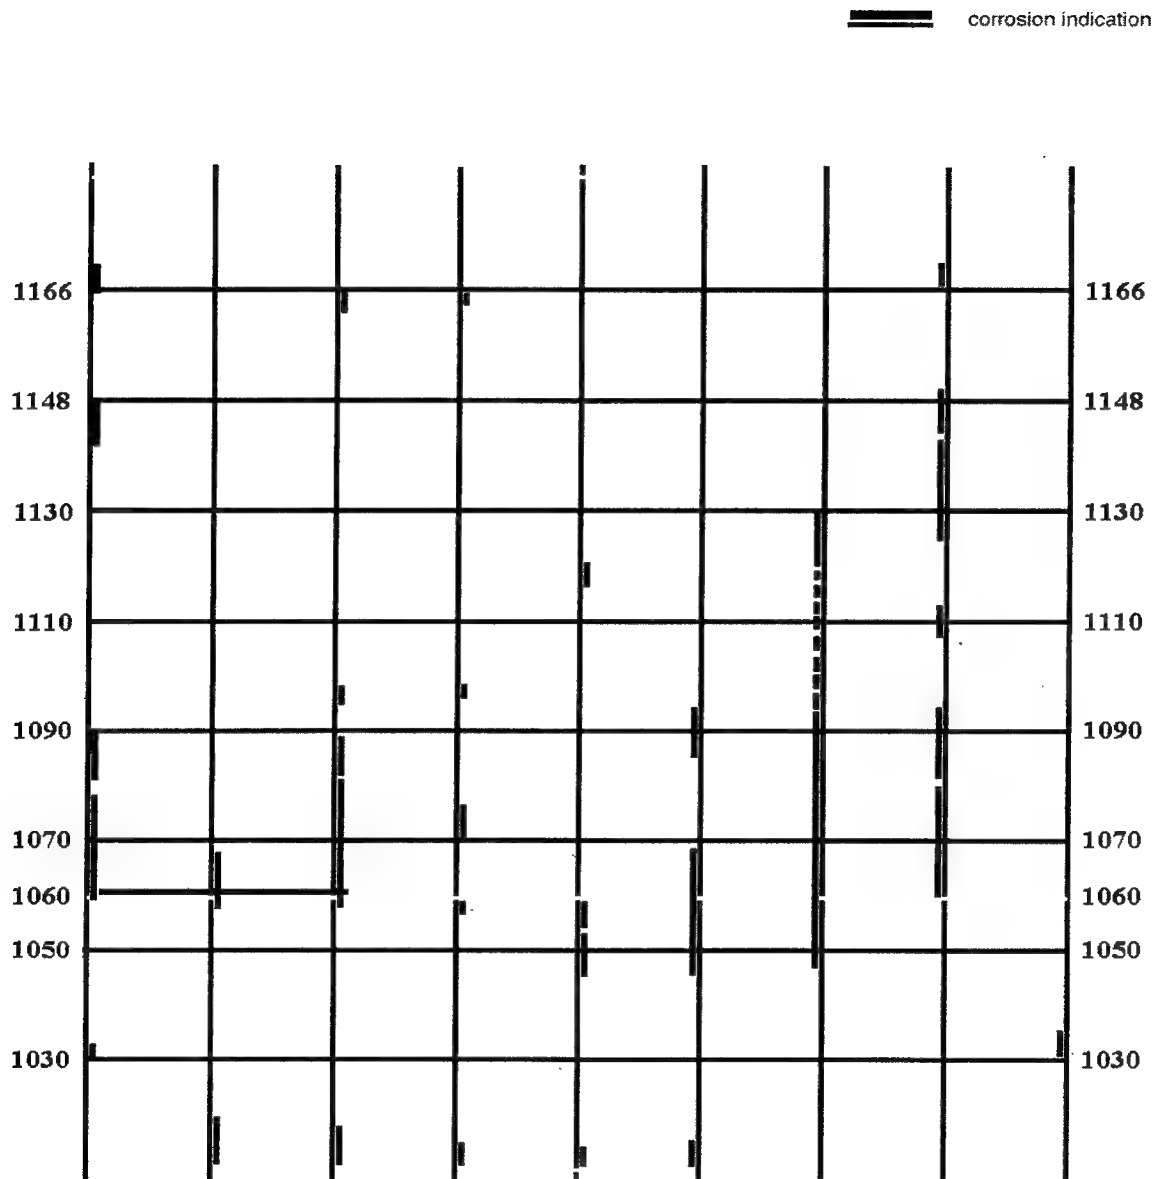
**Figure 2:** Results of *D SIGHT* inspection of B-727 between stringers 26 left and right

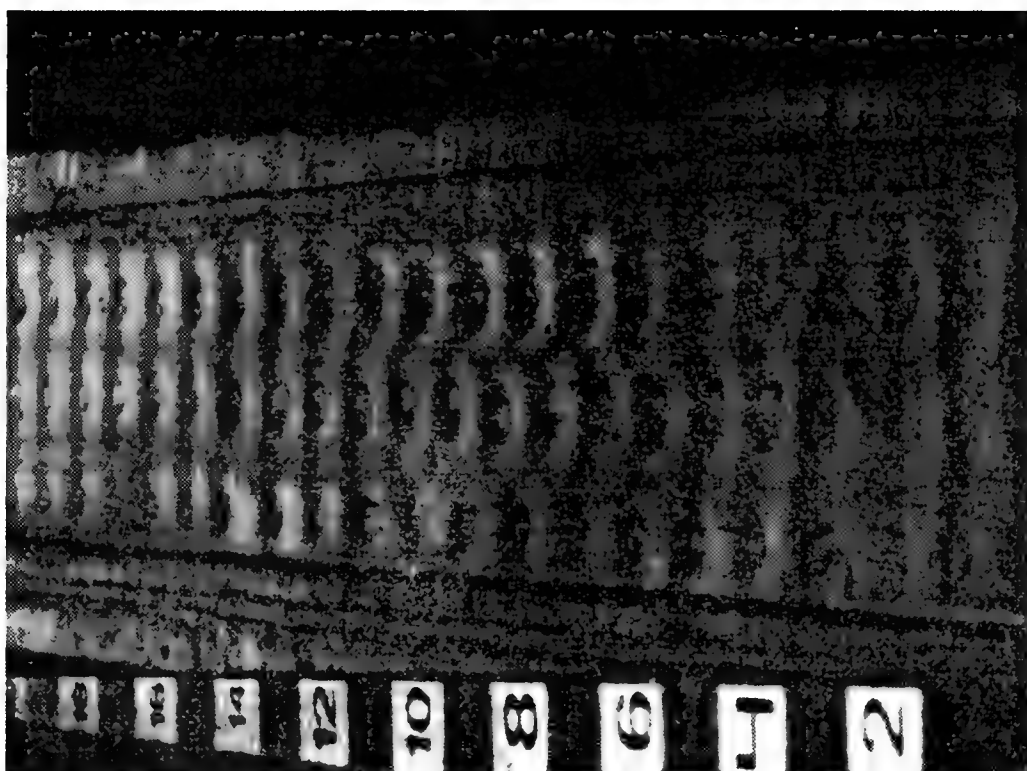
B727-N4747 SPECIMEN 12 IMAGE 5 - showing extensive corrosion

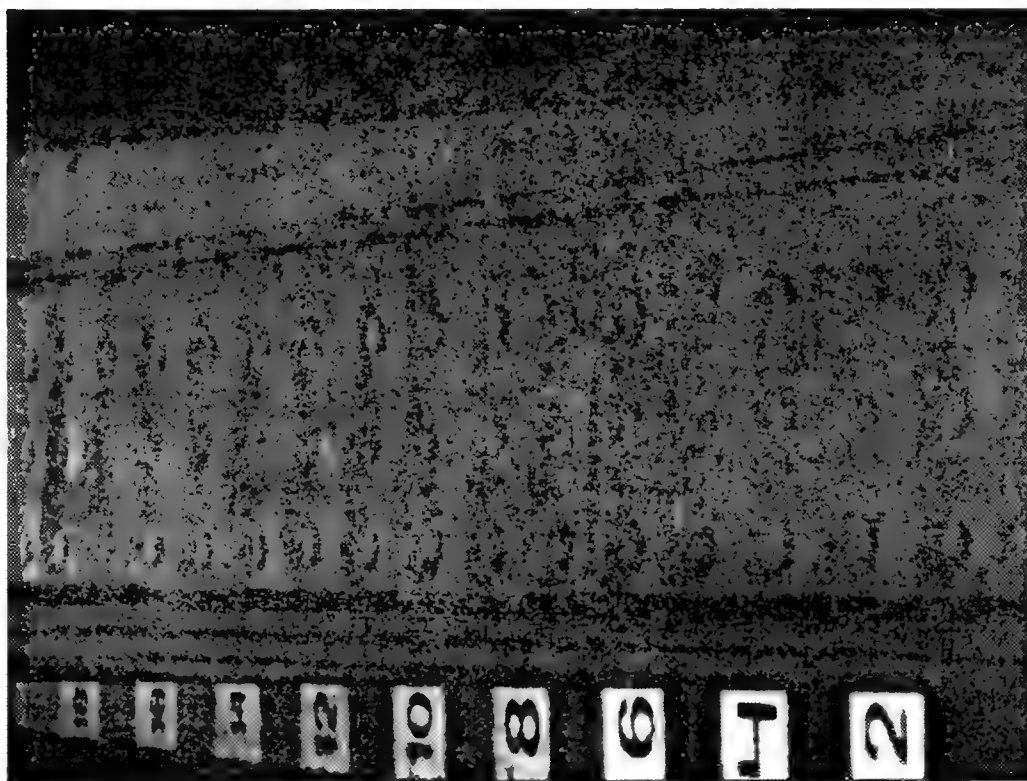
B727-N4747 SPECIMEN 4 IMAGE 1 - showing no corrosion
